R E P O R T
ON THE REVIEW OF THE PLAN
FOR THE REHABILITATION
OF THE SITE
OF THE DOMTAR INC.
FORMER WOOD PRESERVING PLANT,
TRANSCONA, MANITOBA

The Clean Environment Commission
December, 1984.

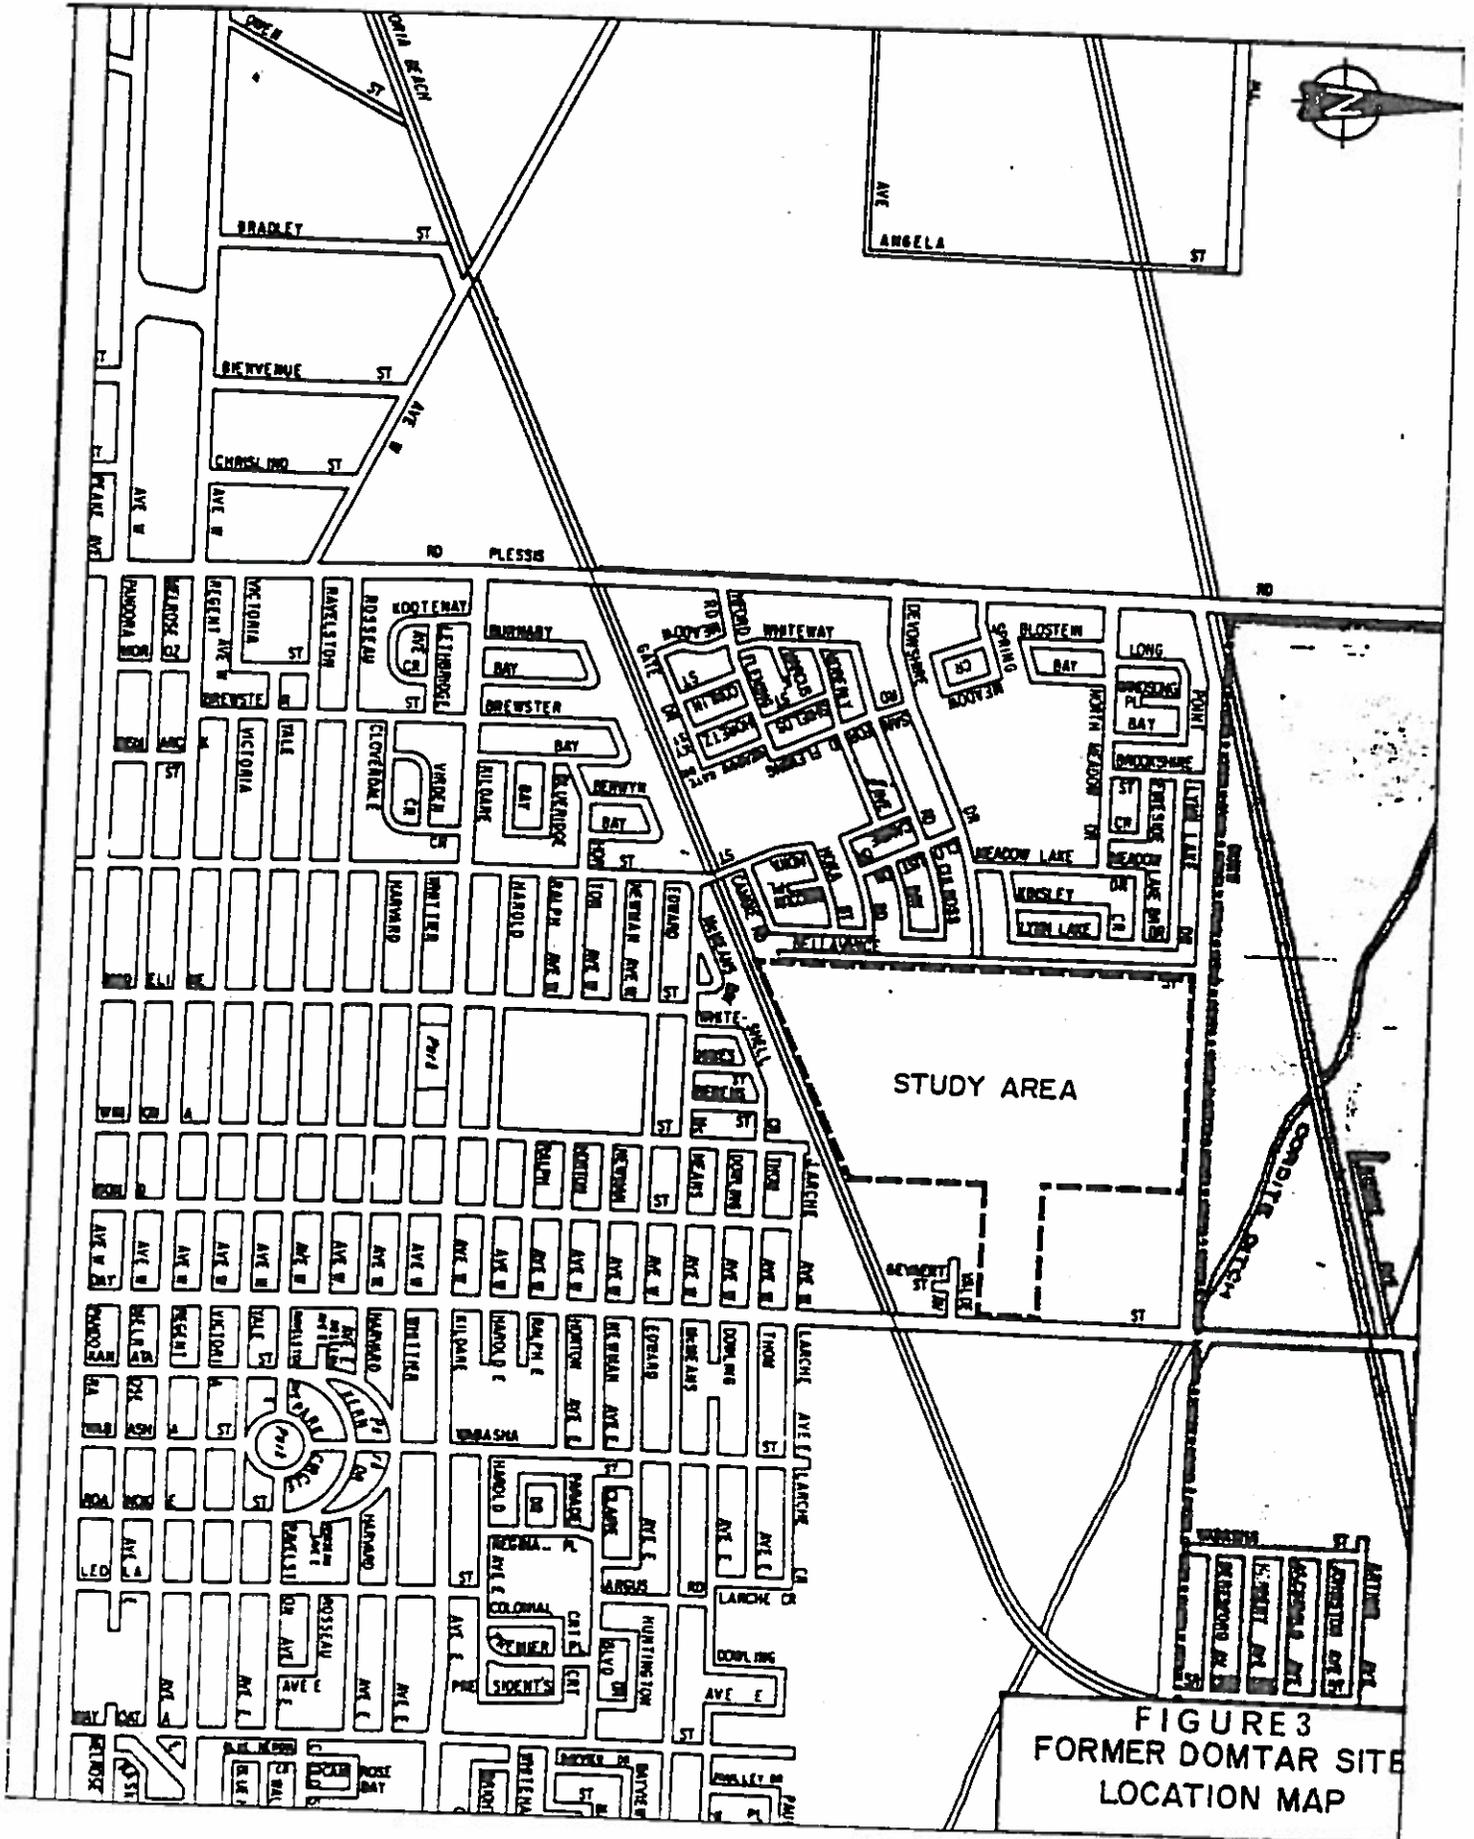
FIGURE 3
FORMER DOMTAR SITE
LOCATION MAP

Following the closing of the Domtar wood preserving plant in October 1976, a detailed study of the condition of the site was carried out by Domtar and their consultant. Figure 3 identifies the general study area and its relationship to the nearby neighbourhood.

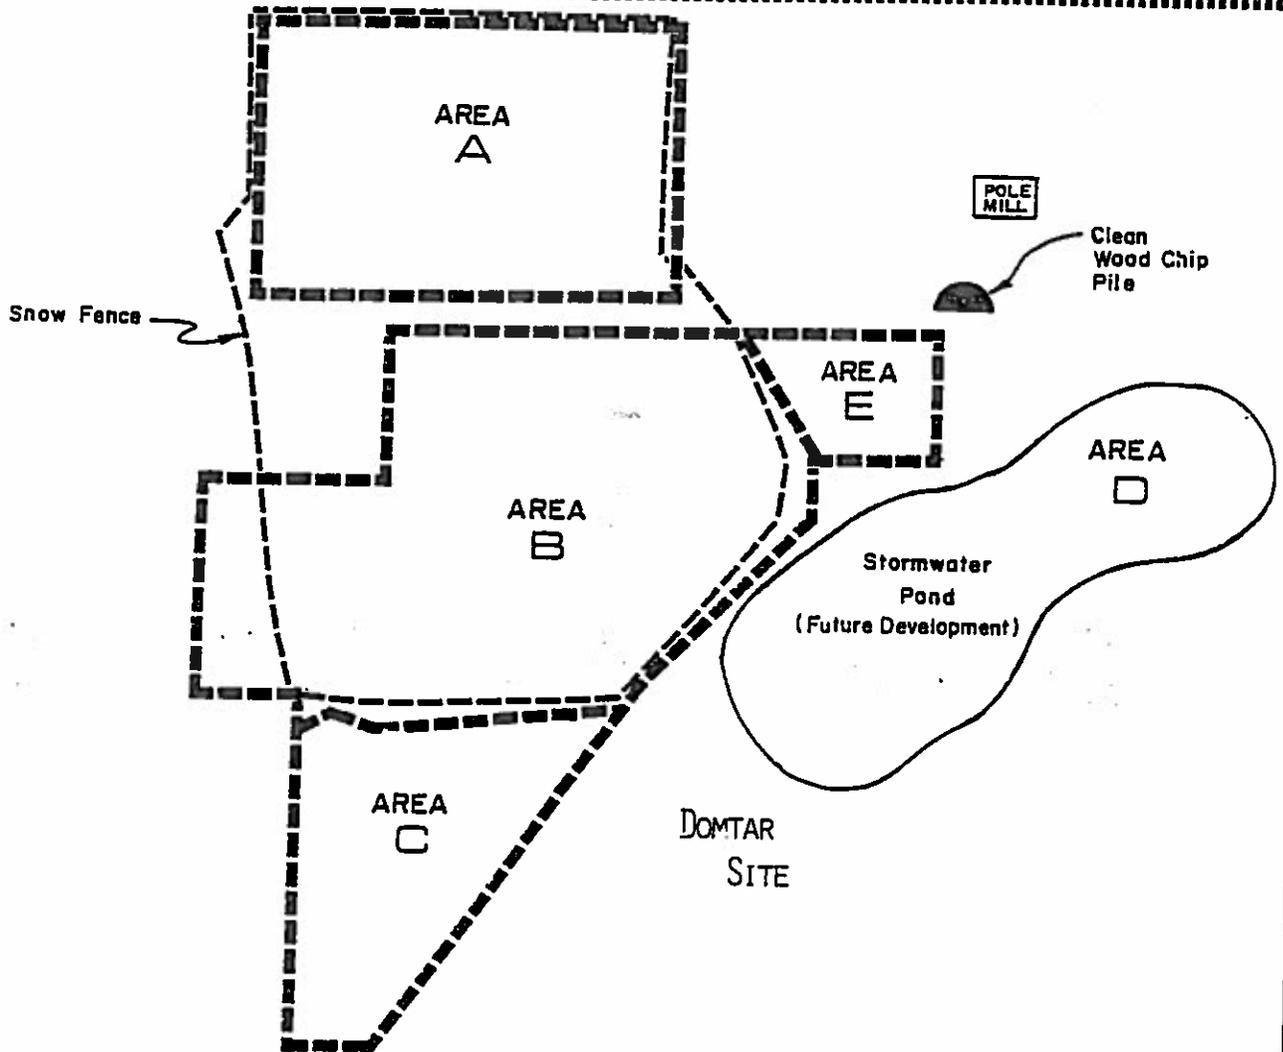
FIGURE 4

The site consists of sixty-two hectares bounded on the south side by the CNR Victoria Beach branch line, on the east by Day Street, on the west by the Lakeside Meadows subdivision, and on the north by Gunn Road (Figure 4). The site is underlain with fifteen to twenty-five metres of highly impervious clay above the bedrock aquifer.

Four areas with different degrees of contamination were described within the Domtar site (Figures 4 & 5). Area A, consisting of 2.2 hectares at the location of the former plant site, contained the highest residue of preservatives. Area B includes some 3.5 hectares at the location of the former evaporation pond which was used for process waste disposal during the last seven years of operation, where wood chips were used to augment the dykes and soak up the wastes. Area C, 1.6 hectares, is an area of slightly contaminated wood chips and minimal soil contamination. Area E, approximately one hectare, had the highest degree of contamination of wood chips with minimal soil contamination.
